SAFETY ASSESSMENT

Invercargill 66 KV Poles

For Powernet

January 2025

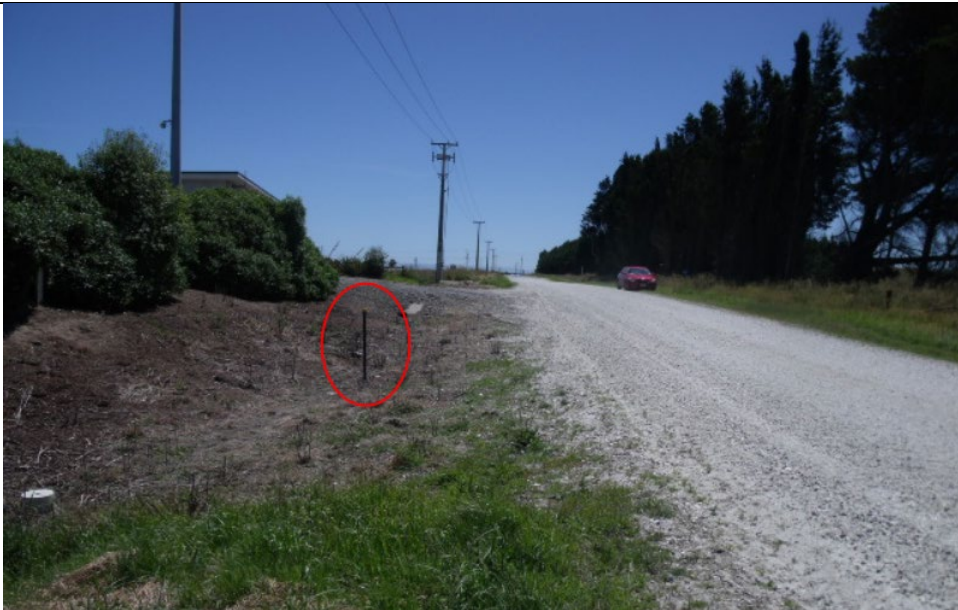
18. It was noted that poles 17 and 18 are in a drainage channel that is deeper than typical on Colyer Road due to the culvert under a vehicle crossing. This leads to a greater clearzone being recommended. The shoulder around poles 17 and 18 should be raised to be a more consistent gradient with the remainder of the shoulder while still allowing longitudinal drainage and reduce the risk of the poles being struck by an out of control vehicle.

- Locate the new poles as close as possible to the property boundary.
- Raise the shoulder of the road around poles 17 and 18.

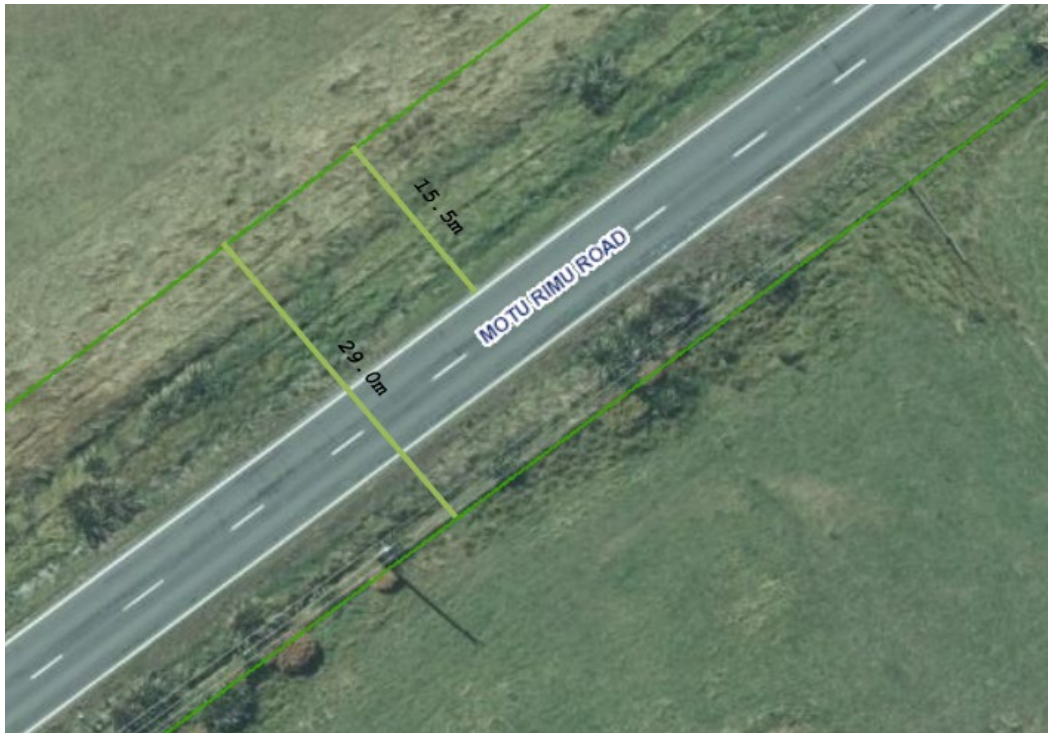
24. The ICC property boundary aerial photo shows that Motu Rimu Road is off set from the centre of the road reserve. The road reserve is about 29 metres wide and the northern

side of the road is about 15 metres between the boundary and the carriageway. This width appears to be consistent between poles 33 and 42. These poles could be located closer to the boundary than has been indicated ensuring they are outside of the clearzone.

- Locate the new poles 33 to 42 as close as possible to the property boundary.
- Consider providing a barrier around pole 43.
- Ensure Pole 44 is located close to the property boundary and behind the soil mounds.
- Erect poles 47 to 50 on the southern side of the swale drain.
- Erect poles 51 to 56 as close as possible to the boundary.

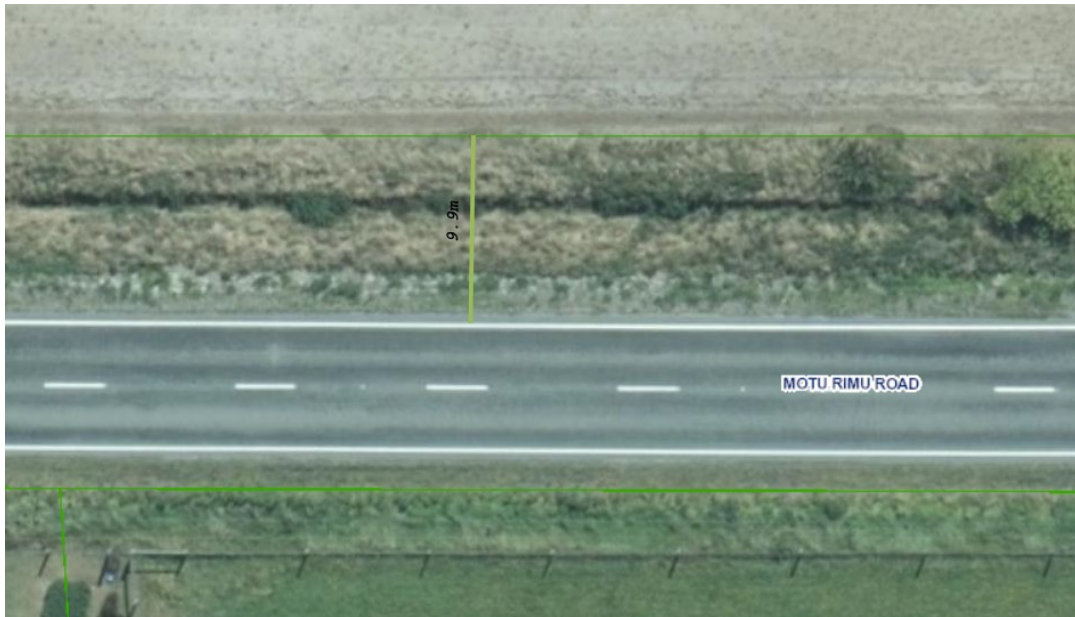
30. The reserve width for poles 51 to 56 is about 10 metres and poles can be located outside the clearzone.

31. Wilson Road north is effectively a private road. Pole 56 will be far enough from the carriageway of Motu Rimu Road that it should not restrict sight distance for a driver exiting Wilson Road north.

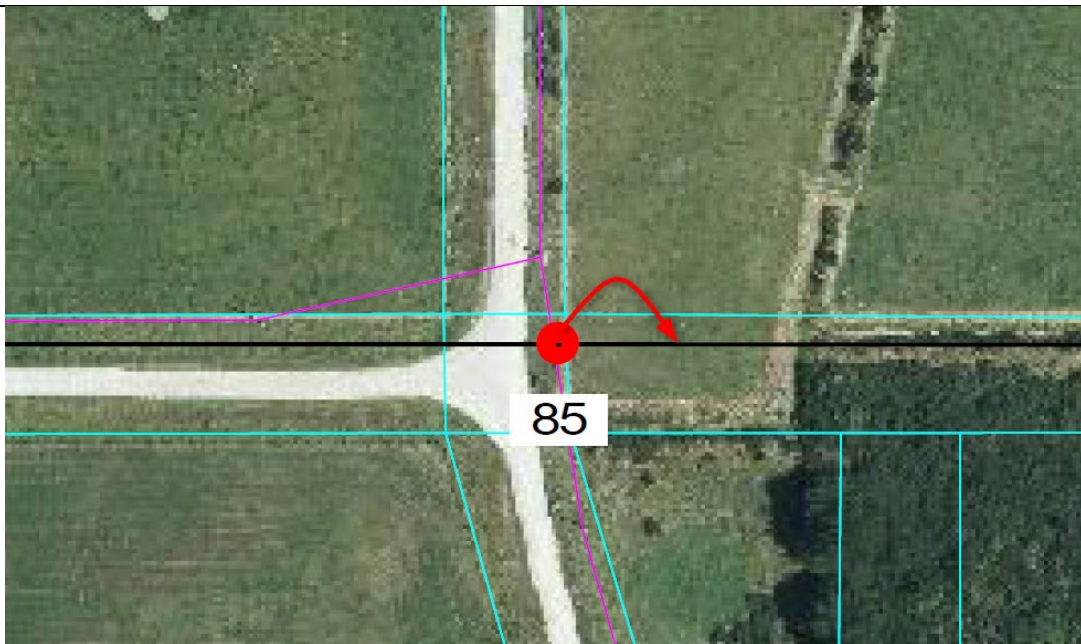
36. Pole 85 is located at the end of Murphy Road on Wixon Road. The pole could be exposed to being struck by a vehicle that misses the end of the road. There are no lines along Wixon Road that would need to be hung from pole 85. The pole should be moved beyond the clearzone by altering the spacing between poles 83 and 86 and erecting pole 85 in the paddock.

- Relocate pole 85 further north into the paddock.

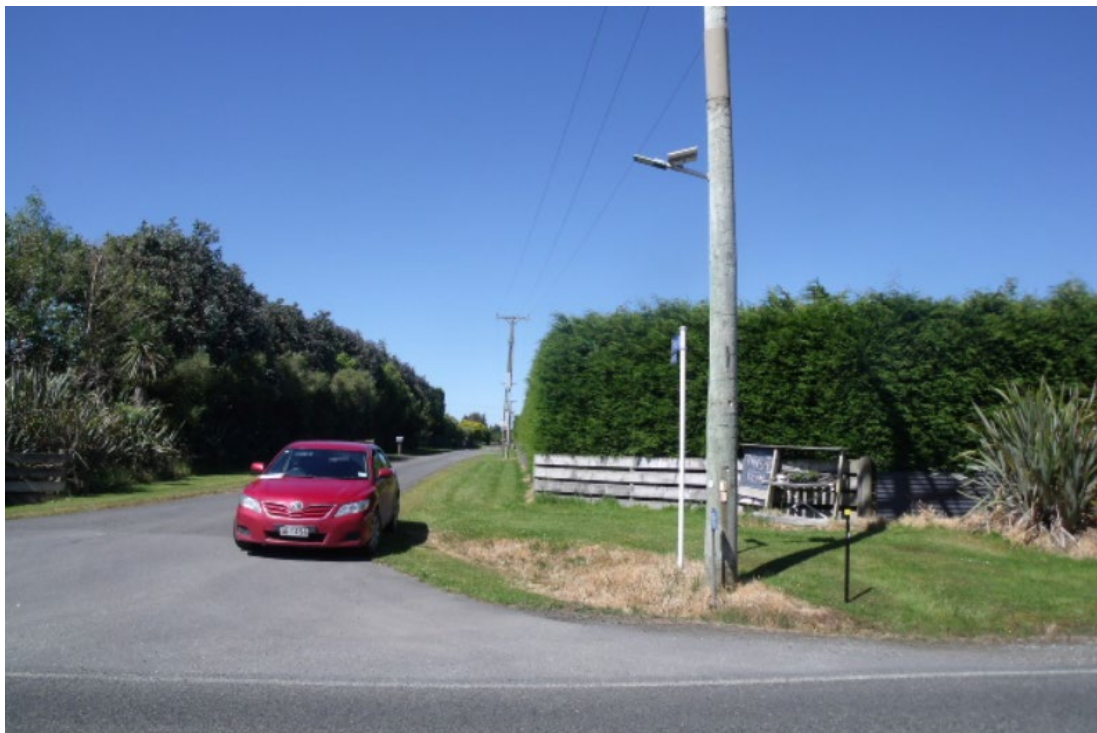
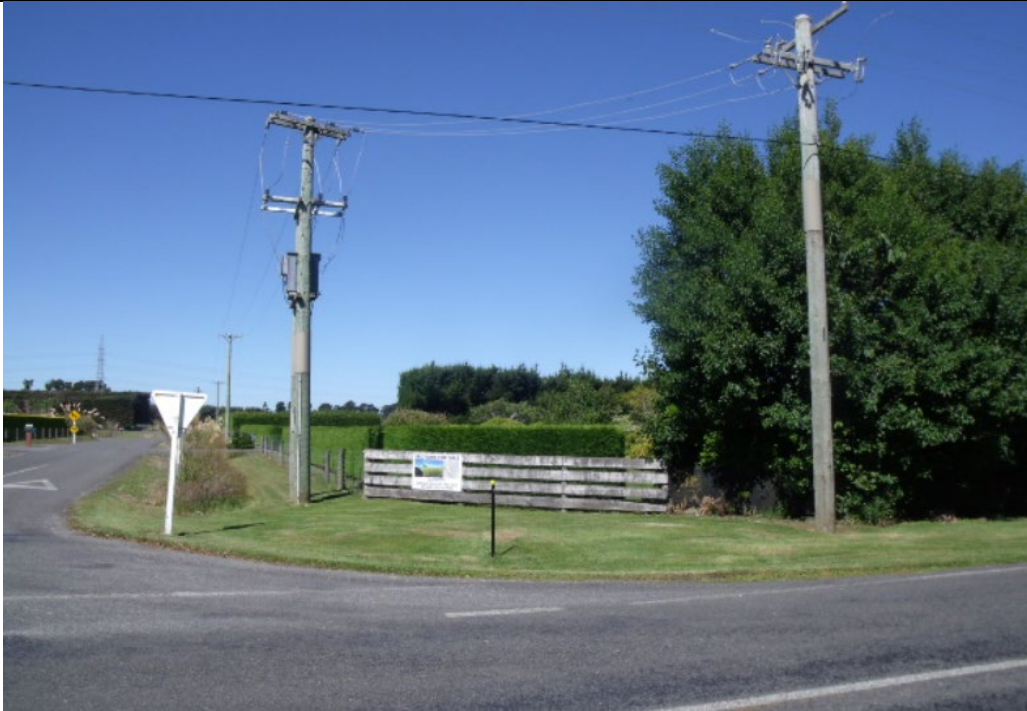
51. There is a private road between 109 and 119 Mill Road and a second cul-de-sac called Millwood Glen. Both have similar designs for the intersections with Mill Road. Poles 143 and 147 are shown in similar positions on these intersections. It is considered that these poles would be exposed to being struck by turning vehicles in their proposed locations as well restricting visibility to the left from the limit line or the side road.

52. Note also the streetlights that will need to be considered.

- Ensure the poles are erected as close as possible to the property boundary.
- Change the locations of poles 143 and 147 as shown.
- Relocate pole 150.

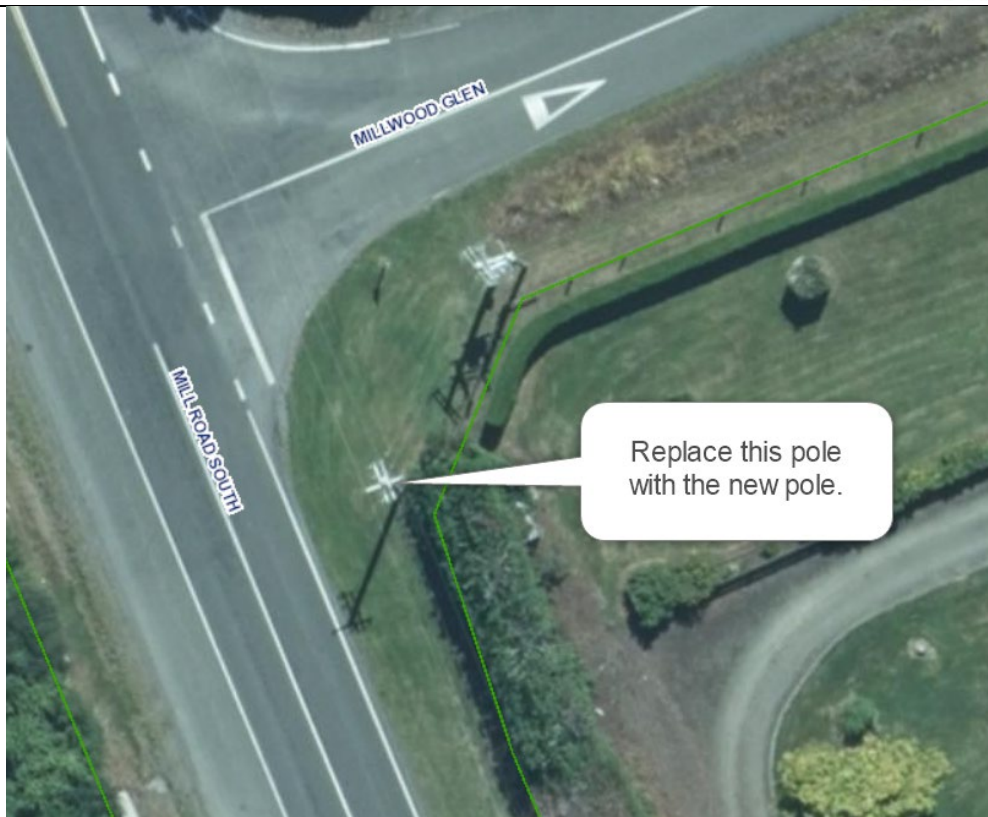
53. The second photograph shows Millwood Glen and it is considered that this shows a reasonable revised solution for the intersections. The boundaries are splayed to allow for the sight triangles and the wooden pole on the right is an appropriate location for the new pole to follow the boundary without causing aerial trespass. It is less likely to cause a visibility obstruction than if it was erected where the waratah is shown and will be less likely to be struck by a vehicle manoeuvring at the intersection.
54. It is considered that poles 143 and 147 should be located as shown in the aerial photo below with the side road pole to follow the splayed boundary. Note that streetlighting will need to be considered.

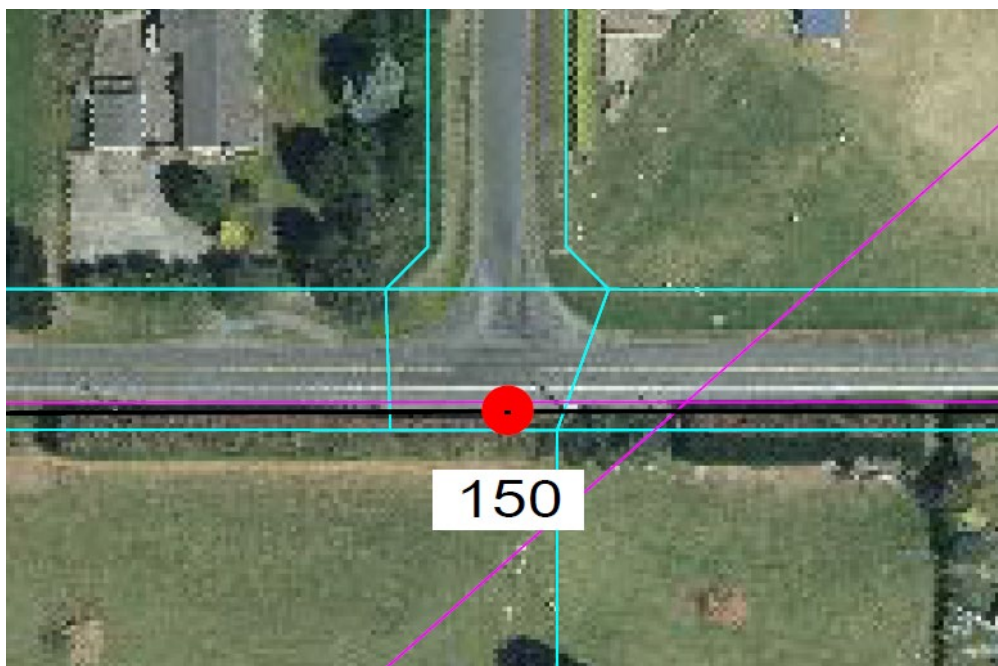
55. Pole 150 is shown directly opposite the Milton Park Road intersection. This pole would be exposed to potentially being struck by any vehicle eastbound on Milton Park Road failing to stop at the intersection. The pole should be relocated to the side along Mill Road so that it is not in the direct alignment of Milton Park Road.

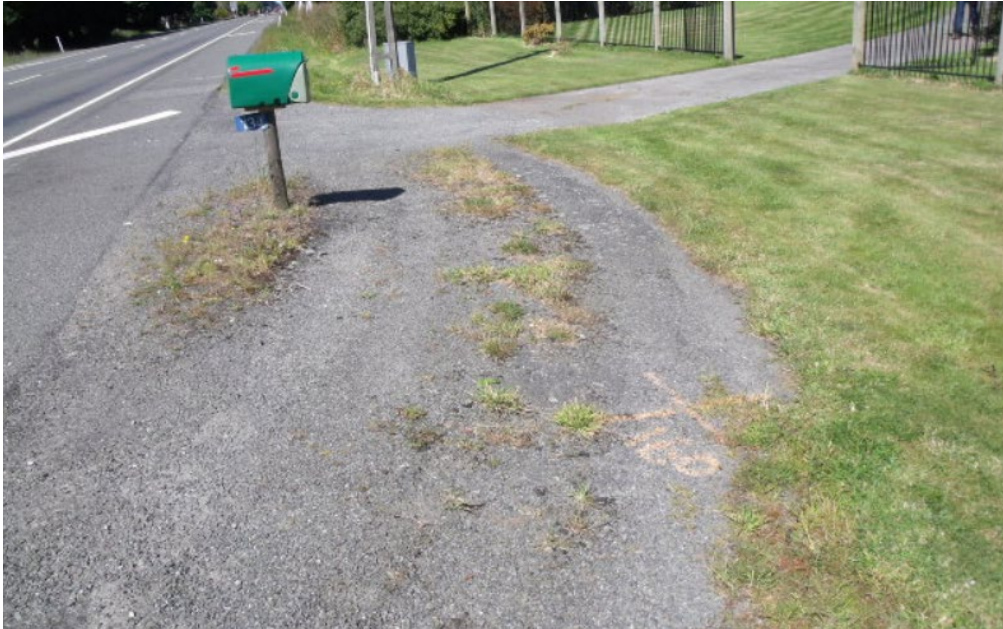
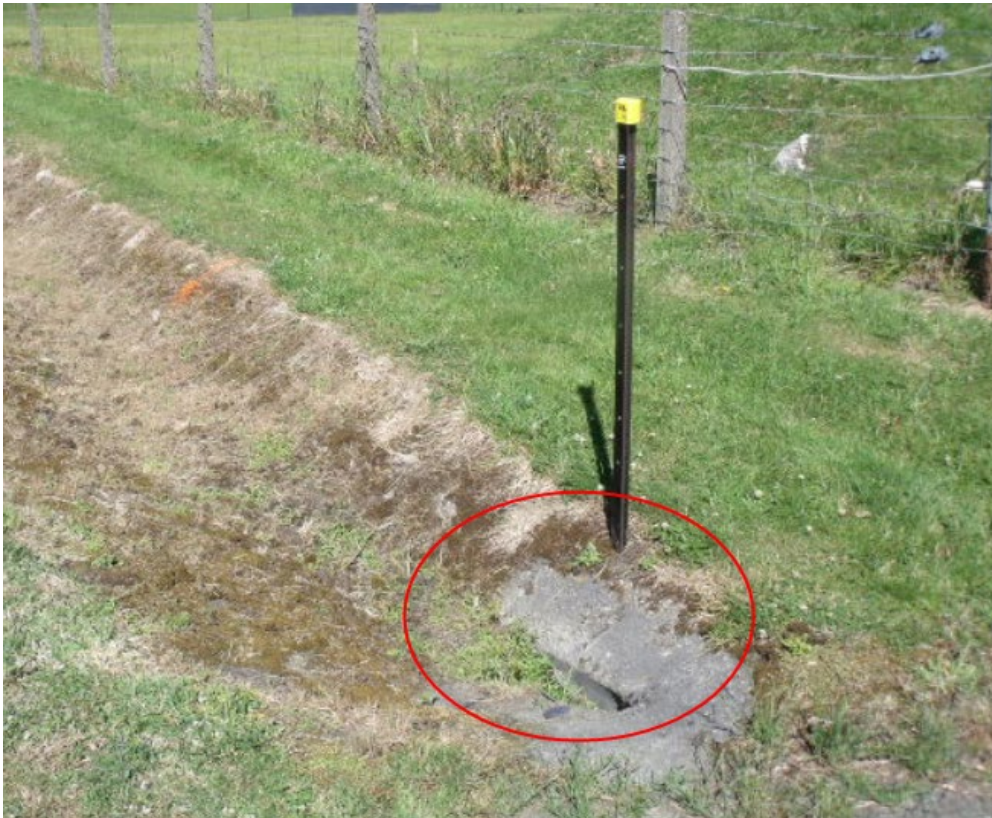
64. Although protected by guardrail, the poles will need to be located away from the vehicle crossings. It is noted that some of the poles were located close to the culverts under the vehicle crossings. These would impede drainage performance and

maintenance of the culverts as well as restricting visibility from the vehicle crossing. This was particularly noted for poles 160, 161 and 163. Where possible, the large poles should be at least 5 metres from a residential vehicle crossing to allow a driver to see past the pole towards oncoming traffic without needing to pull onto the sealed shoulder. Pole 160 also is shown within the manoeuvre area for the mailbox.

- Ensure the poles are erected as close as possible to the property boundary.
- Erect guardrail along the frontage to protect the new poles.
- Relocate poles 160, 161 and 163 to retain drainage and maintain sight distance.
